TASMANIAN STRATEGIC FLOOD MAP MEANDER RIVER CATCHMENT MODEL CALIBRATION

REPORT

AUGUST 2021

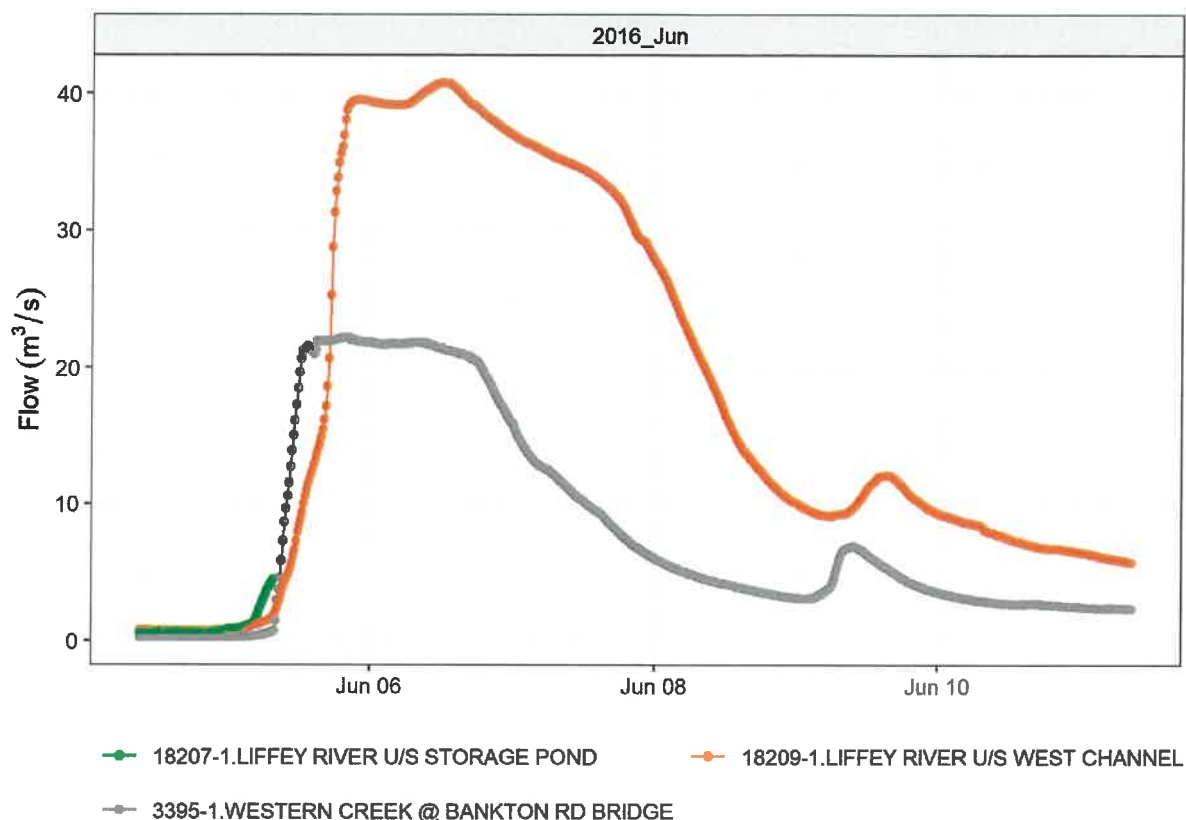
Diagram 1: Example of gauges excluded from calibration where the hydrograph is cut off (18207-1) or is unrealistically flat at the top (18209-1, 3395-1)

Review of data for the calibration events shows that two of the gauges on the Liffey River and the gauge on Western Creek do not appear to be able to record high flow levels (Diagram 1). This is likely due to higher levels being beyond the instrument range, as the same behaviour as shown in Diagram 1 is observed in the level data. One of these gauges is named Liffey River upstream Storage Pond, however this is an off-stream storage and so should not impact the flows, however it is also possible that there is an unknown hydraulic control that could impact on higher flows; rather than being a limitation of the recording equipment at these sites.

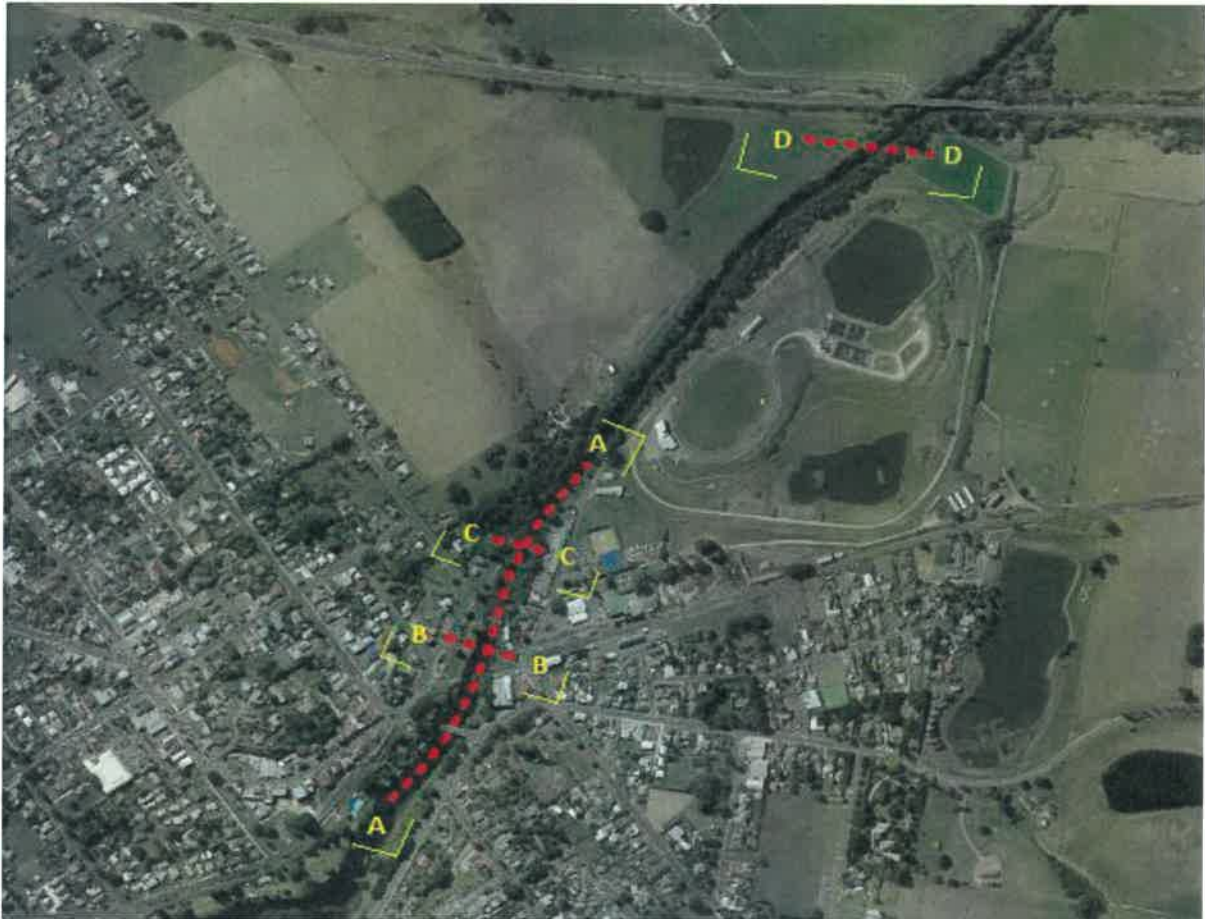
Diagram 4: Meander River through Deloraine - cross-sections.

The base dataset used was the SES state-wide 10 m DEM (including bathymetry) only. The 2 m DEM is not used in this catchment because it does not improve the 10 m DEM in critical areas such as the stream gauge locations, due to issues with representation of the channels. Examples of the issue with representation of the channels through Deloraine are shown in Diagram 4 and Diagram 5.

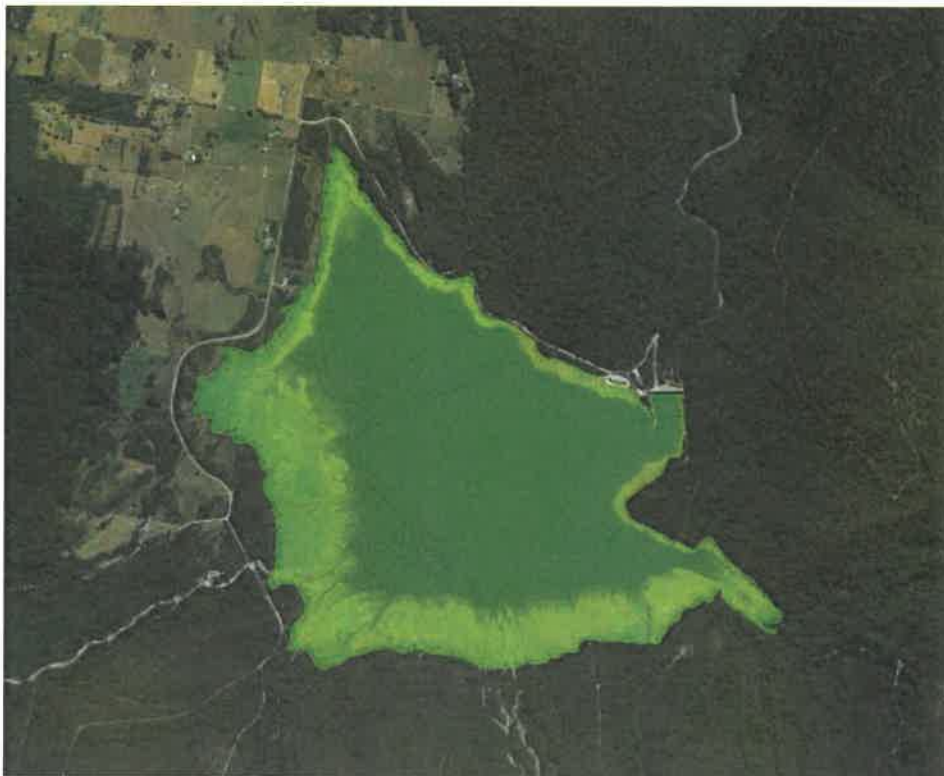
Diagram 9: The modelled initial water extent of Lake Huntsman (Meander Dam).

Meander Dam was modelled with an initial water level of 402 m, which is the full supply level, as no historical dam storage level data was provided. The weir was modelled as a broad crested weir with a spillway length of 50 m and 3 m height, and the crest elevation of 405 m. These measurements were based on the supplied DEM and aerial photography. The modelled initial water extent of Lake Huntsman is shown in Diagram 9.

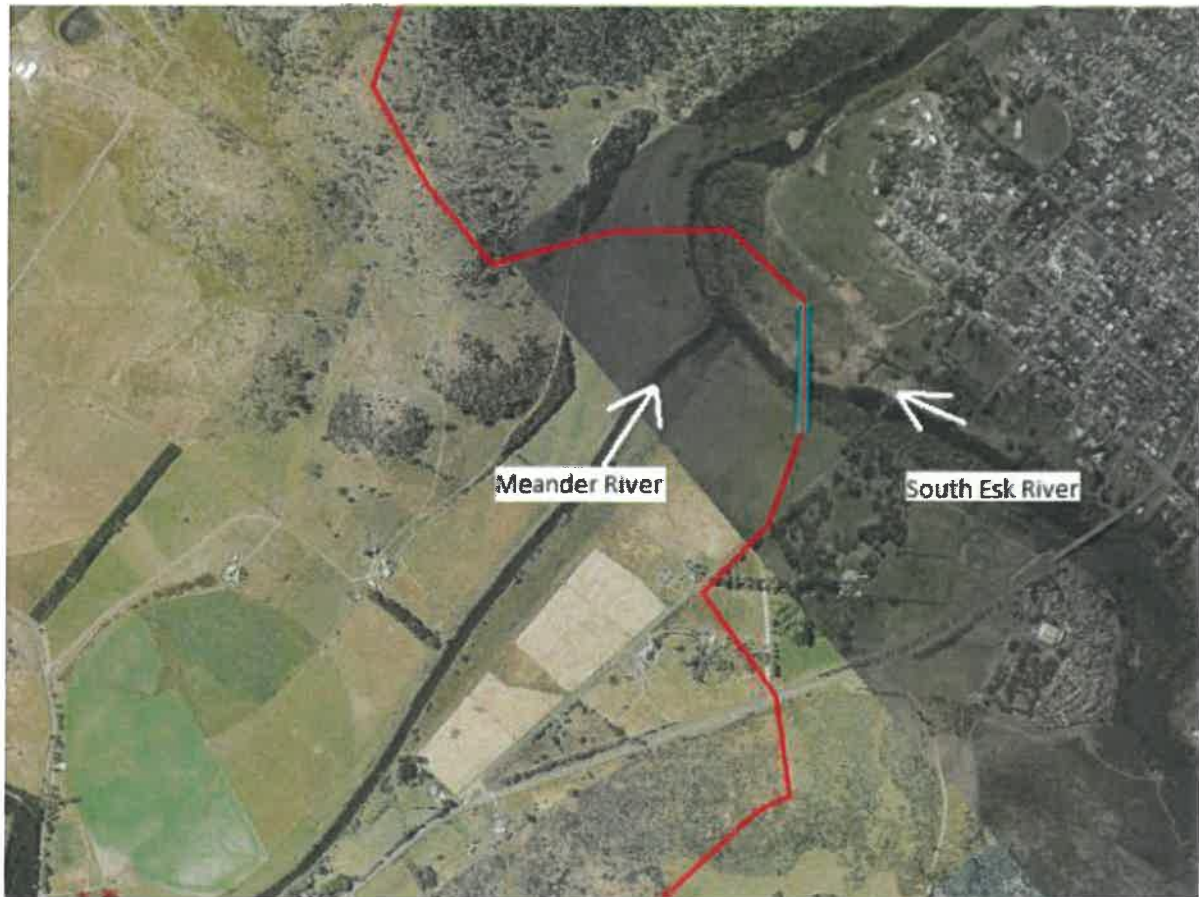
Diagram 10: The inflow boundary (blue) from South Esk River and the Meander catchment boundary (red) which is set as normal condition of the outflow.

Downstream boundaries were applied at the base of the model to provide interaction with the flow from the South Esk River. For the calibration events, the hydrographs of stream gauge 181 South Esk River at Perth, 733 Macquarie River at Cressy Pump and 18219 Back Creek at Wilmores Lanes were combined and used as the flow at the tailwater boundary of Meander River in the South Esk River. Diagram 11 to Diagram 13 show tailwater boundaries that were used in the model.

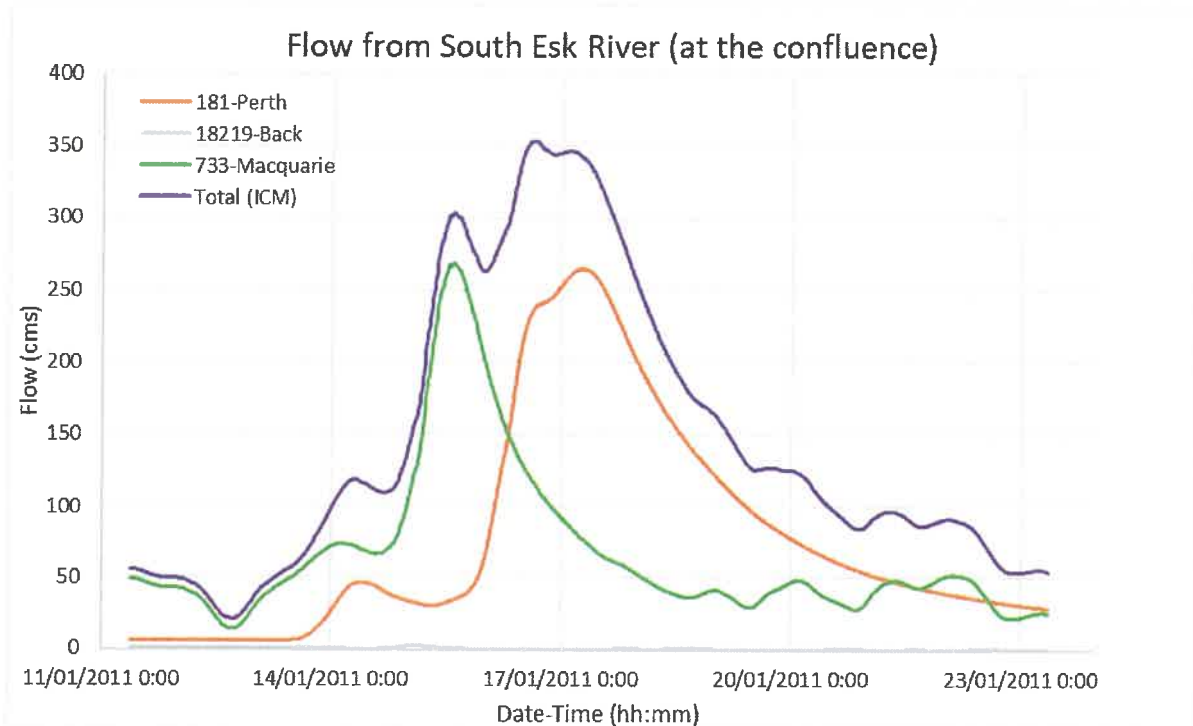
Diagram 11: The flow in the South Esk River at the tailwater boundary of Meander River in January 2011 event.

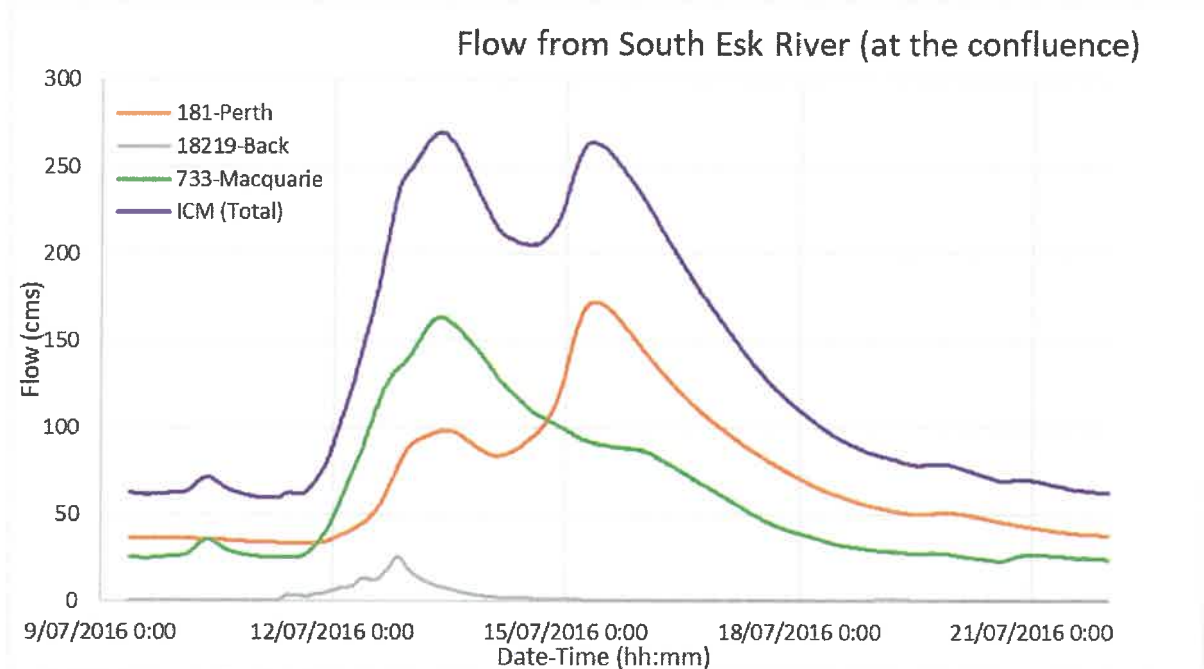
Diagram 13: The flow in the South Esk River at the tailwater boundary of Meander River in July 2016 event.

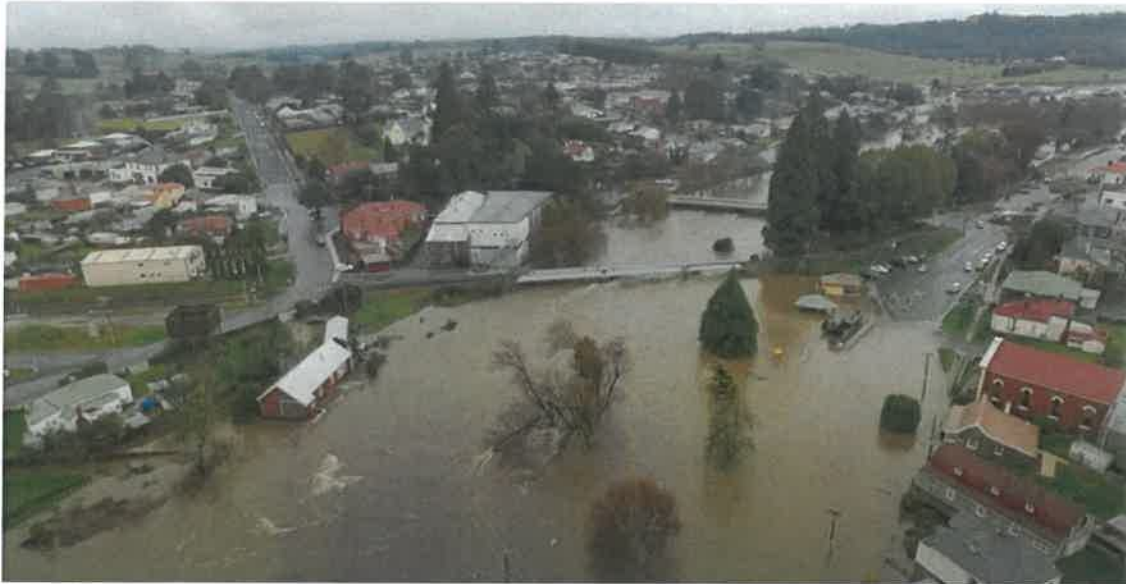
Photo 1: Image taken from the “Flooded Deloraine” video posted by Rod How on YouTube (How, R 2016).

Through the town, specifically focussed on the main bridge, the modelled flood extent is larger compared to the image in the video which is consistent with the understanding of the model overestimating the levels through the township. Diagram 28 presents the comparison through this area.

To further understand the issues present, a review of other available information was undertaken to determine if the model was acting in a reasonable manner. This has been undertaken by using the video “Flooded Deloraine” posted by Rod How on YouTube (How, 2016) and from photography present on The Examiner Website (Dolan, C, 2017). Noting the peak of the event occurred at 6 pm, which is full darkness in June, the levels present in the images are unlikely to represent the peak of the event however are deemed to be representative given the information available.

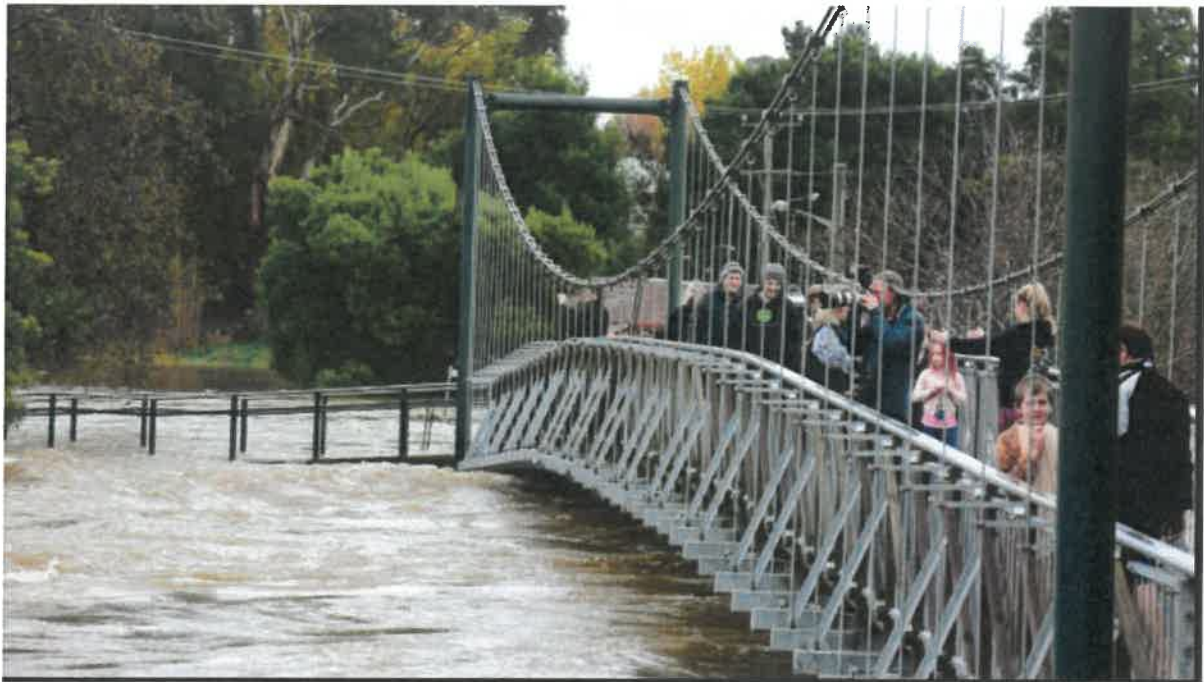
Photo 2: Deloraine Footbridge – Flood Level (www.examiner.com.au)

A review of levels downstream of the weir has also been undertaken, focussing on the footbridge. Within the hydraulic model a recorded flood level of 231.2 mAHD is present at the footbridge. Based on photography provided, the water level at the footbridge looks to be 200-400 mm below

the soffit (Photo 2). While no survey of the footbridge is present, it is estimated to be of a similar level to Racecourse Drive to the east of the structure, which is roughly 231.4 mAHD in the provided DEM. Based on this information the levels look generally appropriate.

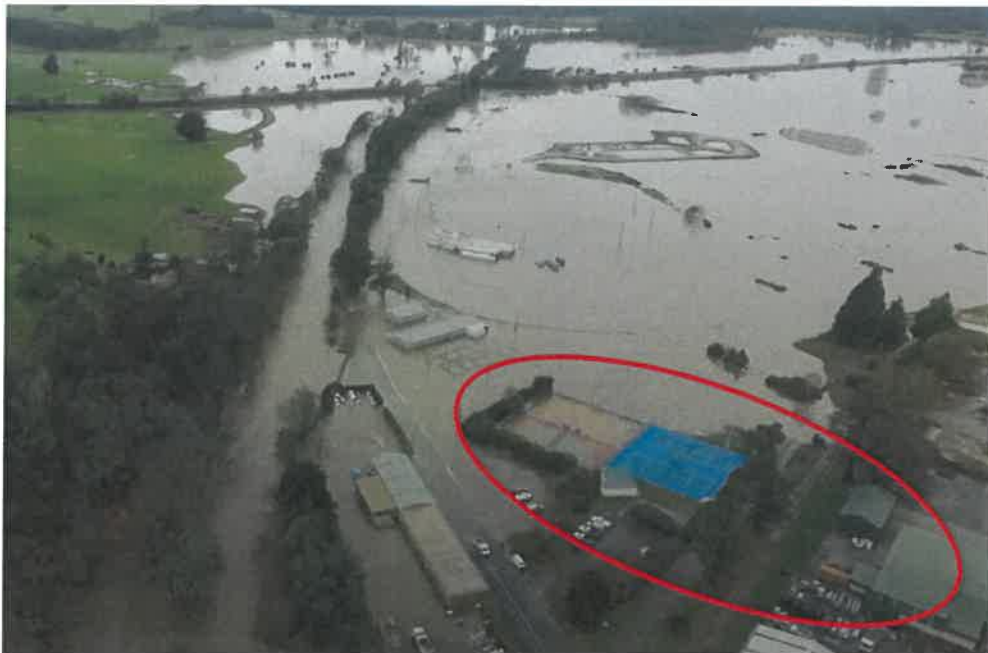
Photo 4: taken from the "Flooded Deloraine" (How, R 2016).

Another location where a significant amount of surveyed data was available was along the Porters Bridge Road near the junction of the Bass Highway. A review of the extent of the backwater was undertaken. Based on the imagery available, the provided flood extent looks to overestimate the level in this location and the model is also over estimating at the Bass Highway. In general, the model extent and the surveyed extent provide a good match. As the structure at the Bass Highway

controls all discharge through the area, the absence of bathymetry may be contributing to the over estimation of levels in the model.
